E3 Home Performance Services, LLC

Wisconsin ENERGY STAR Homes Site Visit 3 Report – Testing and Certification

Builder: Timberlog Works, LLC

Homeowners: Hazelhurst, WI (#T00289)

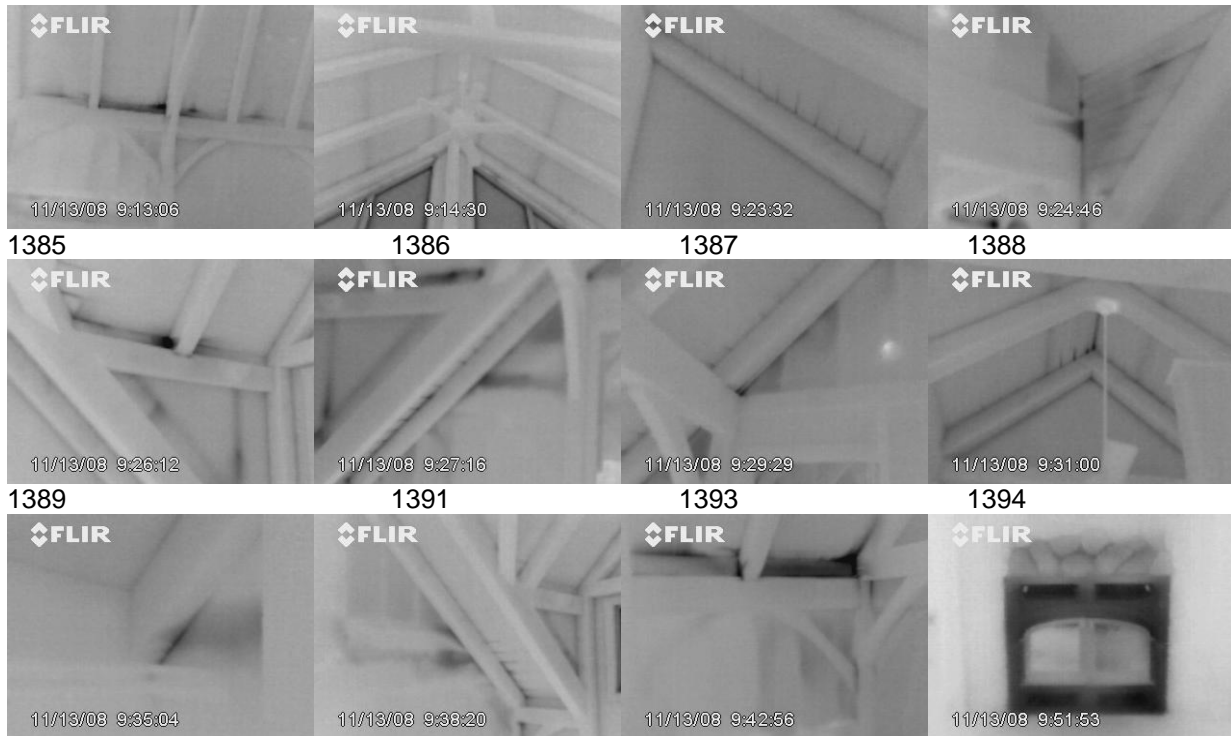
1380	East wall of living room. Air leaks between t&g ceiling and sidewall SIP above beam.
1381	Peak of ceiling above living room, south end. Cold joints (4) between SIPs near peak.
1383	North end ceiling above stairs. Air leaks between t&g boards at gable end.
1384	Wall at top of stair landing past BR door, left (living room) side.
1385	2 nd floor east bedroom, east wall of dormer. Air leak at rafter over beam.
1386	2 nd floor east bedroom, west side, opposite side of 1384. Air leaks from cavity behind where multiple SIPs meet. Also leak at joint of rafter and wall, and at joints of t&g ceiling boards
1387	Above and to right of 1386. This area is framed, air leakage path uncertain.
1388	Peak of ceiling in bathroom.
1389	Loft closet north end adjacent to bathroom.
1391	2 nd floor west bedroom, east wall.
1393	Same area as 1380, taken from loft. After longer depressurization from blower door, leaks are more pronounced in infrared scan.

1394	Fireplace. Source of leak unknown, possibly from inside chase. Air streams out grille at top of fireplace.
